## Case studies and analysis of mine shafts incidents in Europe

Amélie Lecomte, Romuald Salmon, W. Yang, Alec Marshall, M. Purvis, S. Prusek, Slawomir Bock, L. Gajda, J. Dziura, Agustin Munos Niharra

## **Case studies and analysis of mine shafts incidents in Europe**

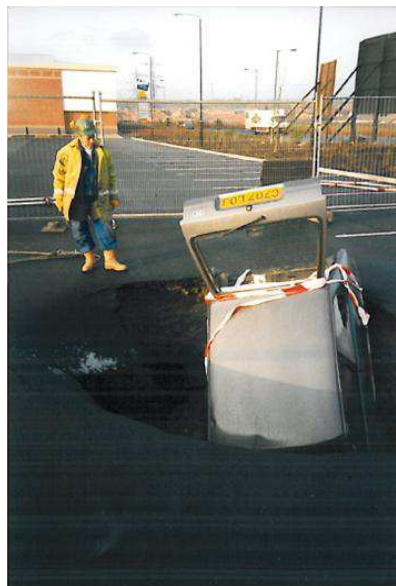
The case of West Midlands Shaft, in England, illustrates this kind of situation. This 3 m diameter circular shaft, 144 m deep, suffered a collapse of ground approximately 3 m diameter and 2.5 m deep in a car park area in 2000. Collapse became apparent when surfacing failed over a void due to weight of a car (Figure 2). Two occupants in the car escaped with only minor injuries.

*Figure 2 : Collapse of ground in the car park area  
(Source: UK Coal Authority)*

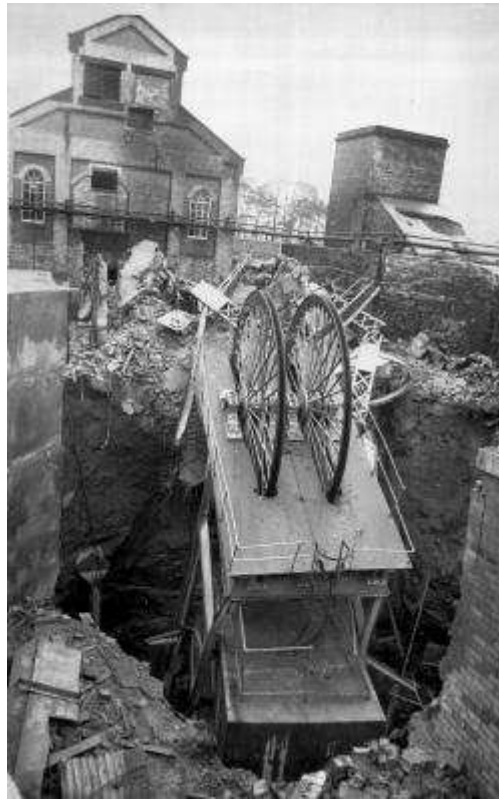
- Coal shaft V, Knurów-Szczygłowice colliery, in Poland. A detailed analysis is presented in Section 3.
- Shaft n°1 and n°2 at Barony Colliery Ayrshire Scotland (England): sunk between 1906 and 1912, shaft n°1 and n°2 are rectangular (resp. [6.4 m x 3.3 m] and [4.9 m x 3.3 m]), wood lined and 633 m deep. In 1960/62, modification of ventilation systems took place. N°1 shaft was originally used as the Downcast / coal winding until 1962. Following completion of works at the shaft head, it was re-commissioned as an upcast. N°2 shaft was an Upcast. After conversion of ventilation system, shaft n°2 collapsed following deterioration of wood lining (Figure 3), that may have been caused by contact with upcast air of high humidity.

*Figure 3 : N°2 Shaft following Collapse (Source: MRSL)*

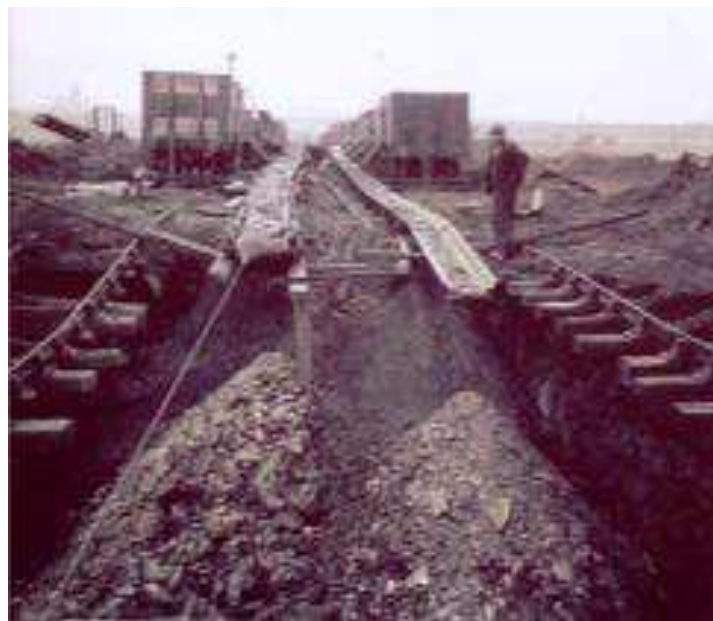
- West Midlands shaft (England), introduced previously.
- Low Hall n°7 (New Zealand Pit) at Abrams Lancashire, in England. The shaft is circular (3.66 m) and 305 deep and was sunk circa 1885. All mining via the shaft was abandoned in 1919 (1924?) although the shaft was retained for ventilation until 1932 (1931?) when it was filled with a reported 8,120T of debris. In April 1945, some 13 years after the mine shaft had been filled the locomotive was shunting a train of 13 loaded coal wagons (full length 86m) when the ground beneath the line cratered and collapsed (Figure 4). The last wagon entered the crater pulling the rest of the train and eventually the locomotive with it. A few days later, when the dust cleared, the front of the locomotive could be made out 30m below pointing upwards.

*Figure 4 : Infilling Shaft Post Collapse (Source: MRSL)*

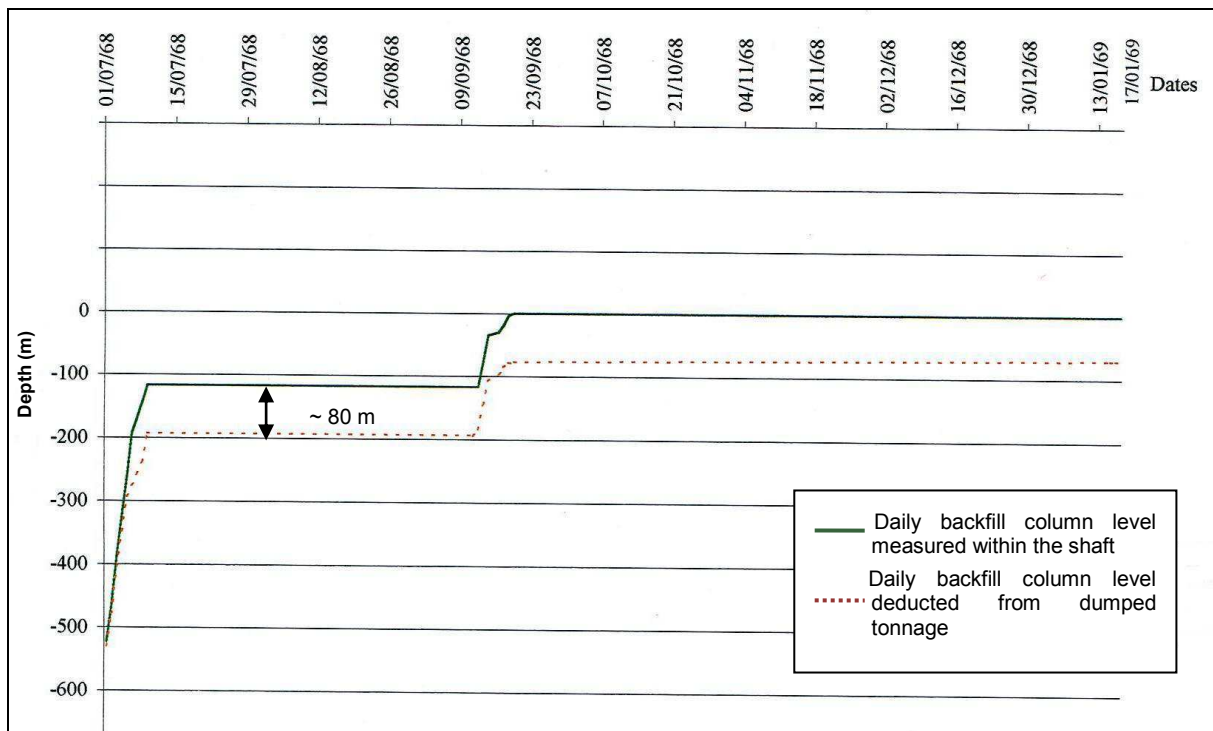
The historic curves deduced from the follow-up of backfill data show sharply the appearance of void formed from the first works of stowing. Figure 9 and Figure 10 show a sensitive and constant distance between the level of backfill material measured in the column of shafts and the level equivalent to the volume of the dumped backfill material. The first one is upper than the second indicating the presence of one or several voids in the column of shafts. Let us note that shafts were not deinstalled before the stowing and the presence of metallic structures within the column of shafts can ease the creation of backfill material vaults.

Figure 9 : backfill level evolution – Shaft n°8 – from 01/07/68 till 17/01/69

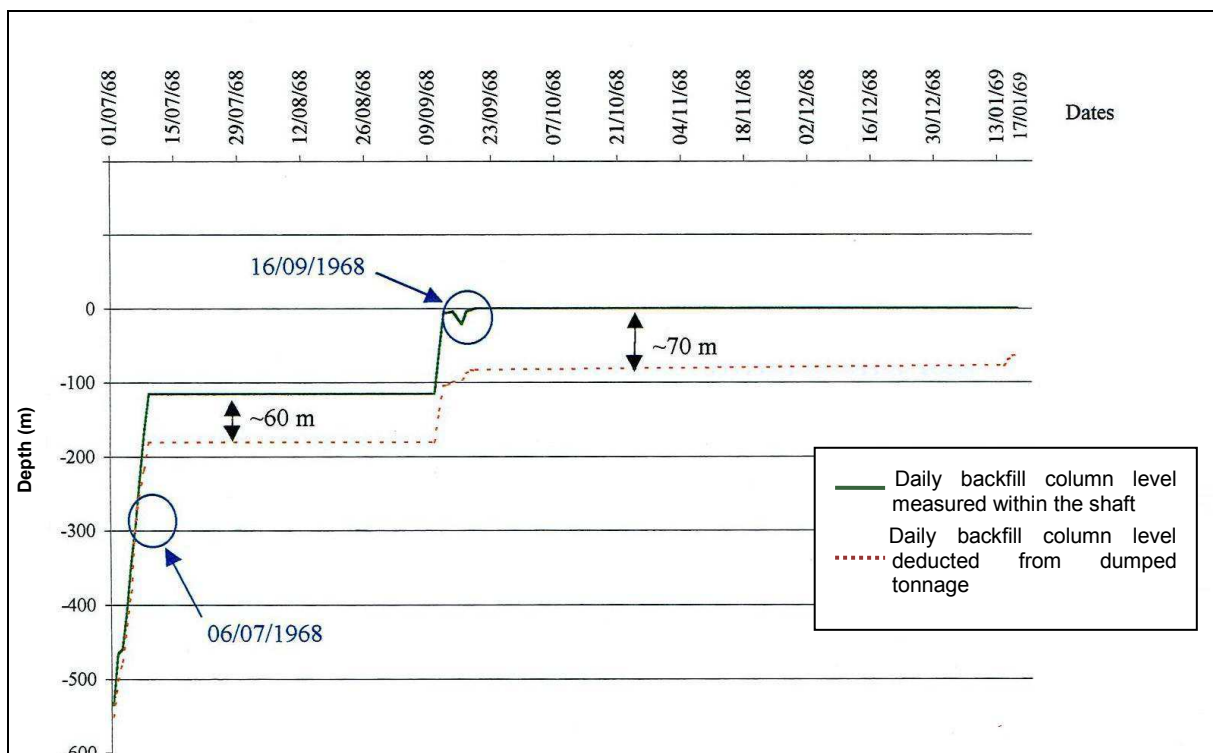
Figure 10 : Backfill level evolution – Shaft n°8 bis – from 01/07/68 till 17/01/69

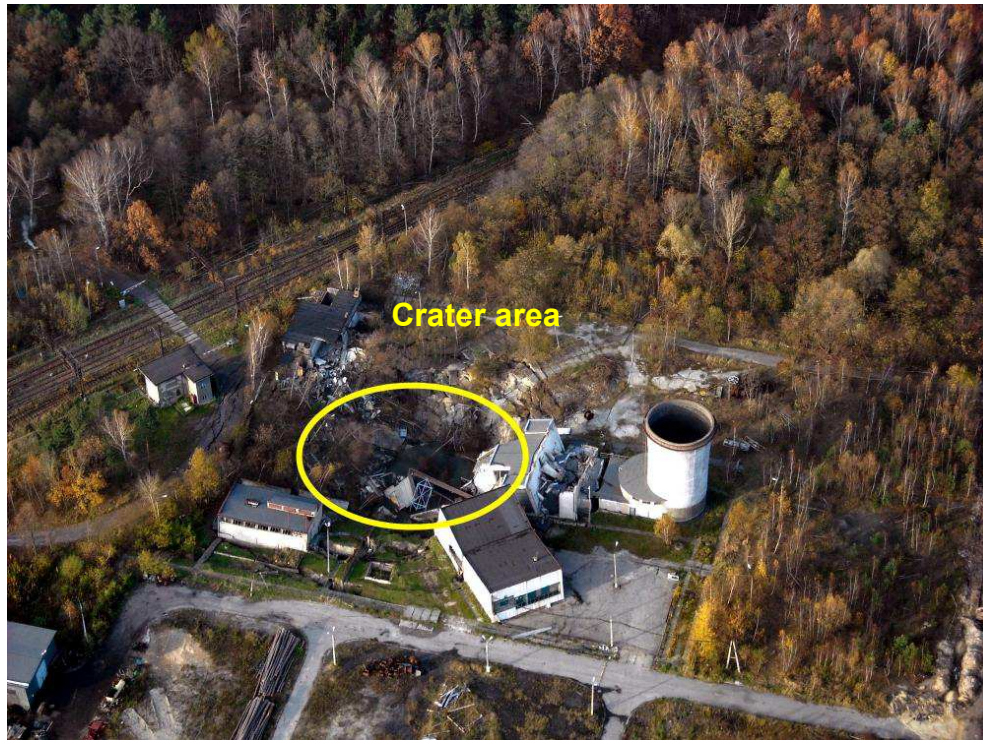
On 4 September 2008 at 4.35 o'clock a catastrophe took place which resulted in shaft lining damage up to a depth of circa 70 m, and afterwards the shaft was spontaneously filled with overburden soil material. This caused that a large crater came into being at the surface that in turn caused damage of building facilities present in its impact zone.

*Figure 13 : General view of the scene of the catastrophe of shaft V from the south  
(Source: GIG / KWSA)*

The crater had a diameter at the ground surface about 60 m, a depth of around 11 m and an estimated volume of about 30,000 m<sup>3</sup>. Horizontal range of fracture zone at the ground surface affirmed on 4 September 2008 amounted to 67 m.

The primary cause of the accident at the shaft was damage to its lining at a depth of 61 m – 67 m. The damage was a consequence of:

1. Irregular mining repeatedly performed in the neighborhood of the safety pillar of the shaft which influenced hydrogeological conditions which in turn destroyed building-engineering stability of the ground-lining system.

## 2. Poor technical condition of the lining of shaft V.

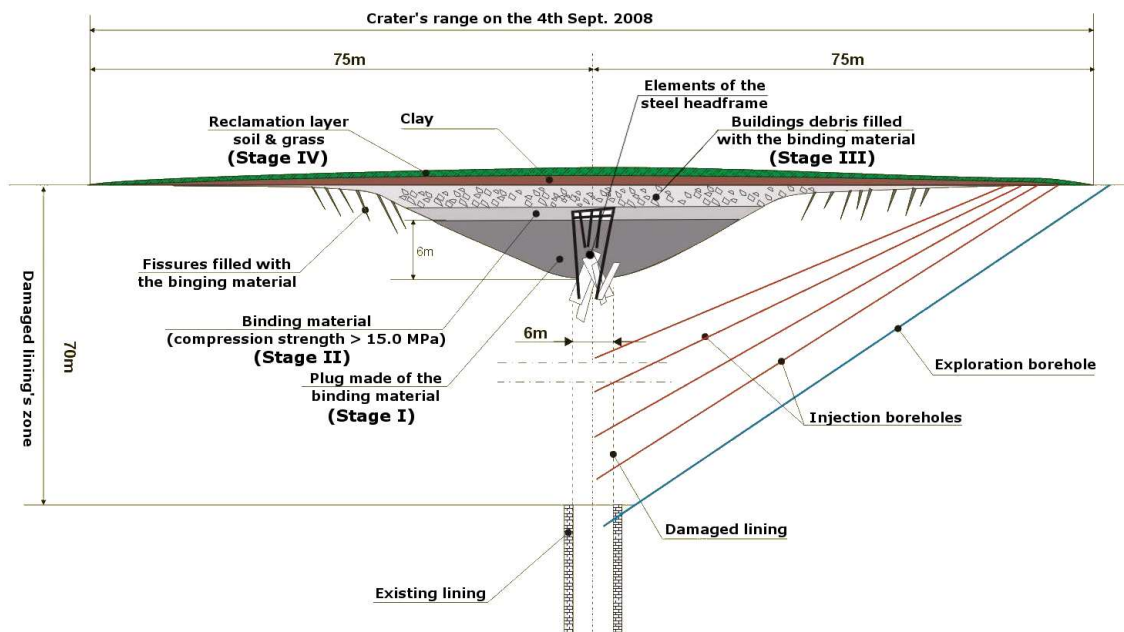
*Figure 14 : Schematic illustration of the crater resulting from the catastrophe of shaft V and its fill*

Empty spaces in the shaft section where the lining damage took place up to the crater bottom were filled with a binder characterised by compression strength of not less than 15 MPa. The spaces were filled after building stoppings at levels 450 m and 350 m. The filling material was supplied through holes drilled from the ground surface in the direction to the shaft at 10 m distance one to another. Before they set to injection, an exploration borehole was drilled to assess the crater's range and scope of damage. Locations of the injection boreholes and the exploration hole are presented in *Figure 14*.

The crater was filled in four stages.

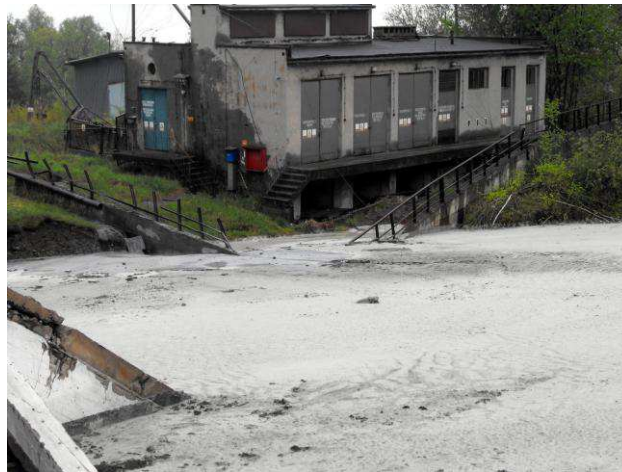
*Figure 15 : The load-bearing layer at the crater – 5 May 2010 (Source: GIG / KWSA)*

*Figure 15 and Figure 16 present results of work performed at Stage II and III.*

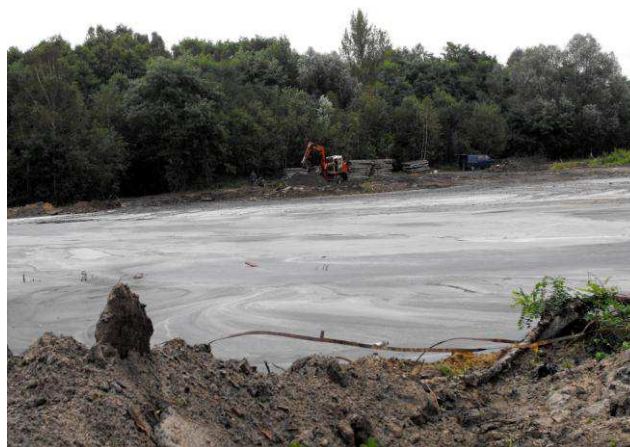
*Figure 16 : Final crater fill with building debris mixed with binding material – 31 August 2010 (Source: GIG / KWSA)*

The third stage (Stage III) included further filling the crater up to the ground surface by means of a mixture of building debris (stemming from demolishing) and a binding material with compression strength of at least 5 MPa. Moreover all fissures that came into being in the vicinity of the crater were filled with the binding material used at the second stage.
